AFML-TR-79-4209

FATIGUE CRACK PROPAGATION AND CORROSION
FATIGUE OF AF 1410 STEEL

S. D. ANTOLOVICH

JANUARY 1980

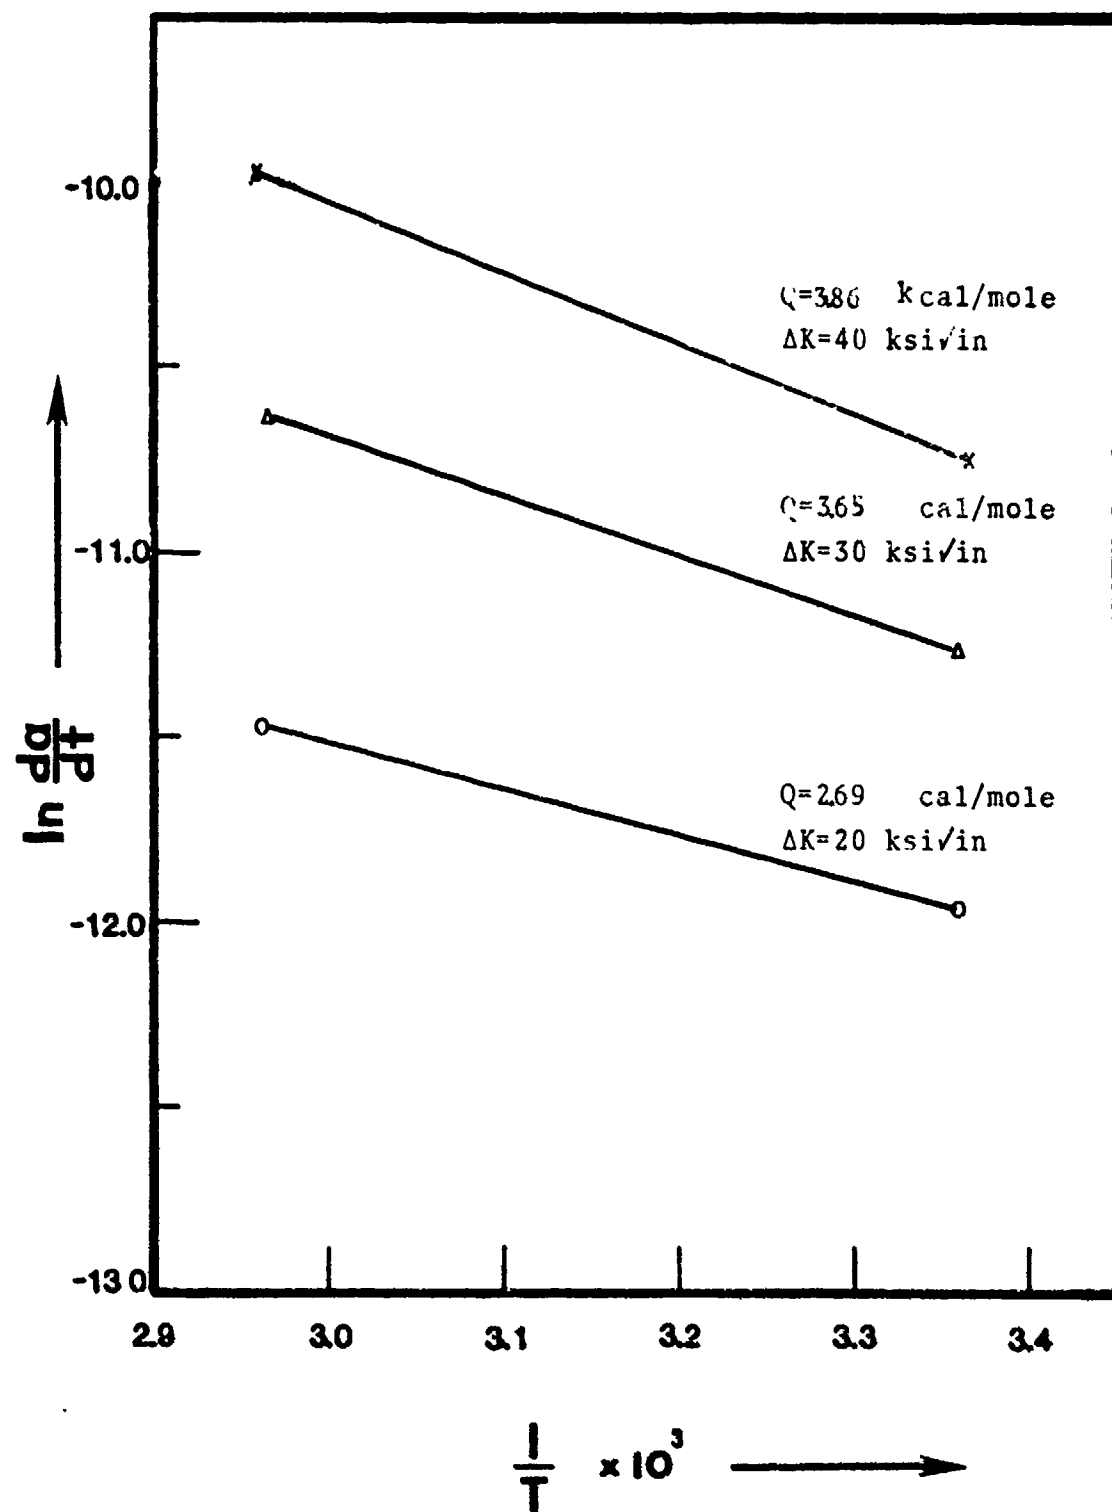
Fig. 52. Plot of $\ln \left(\frac{da}{dT} \right)_{cf}$ versus $\frac{1}{T} (^{\circ}\text{K}^{-1})$ at indicated stress intensity levels.

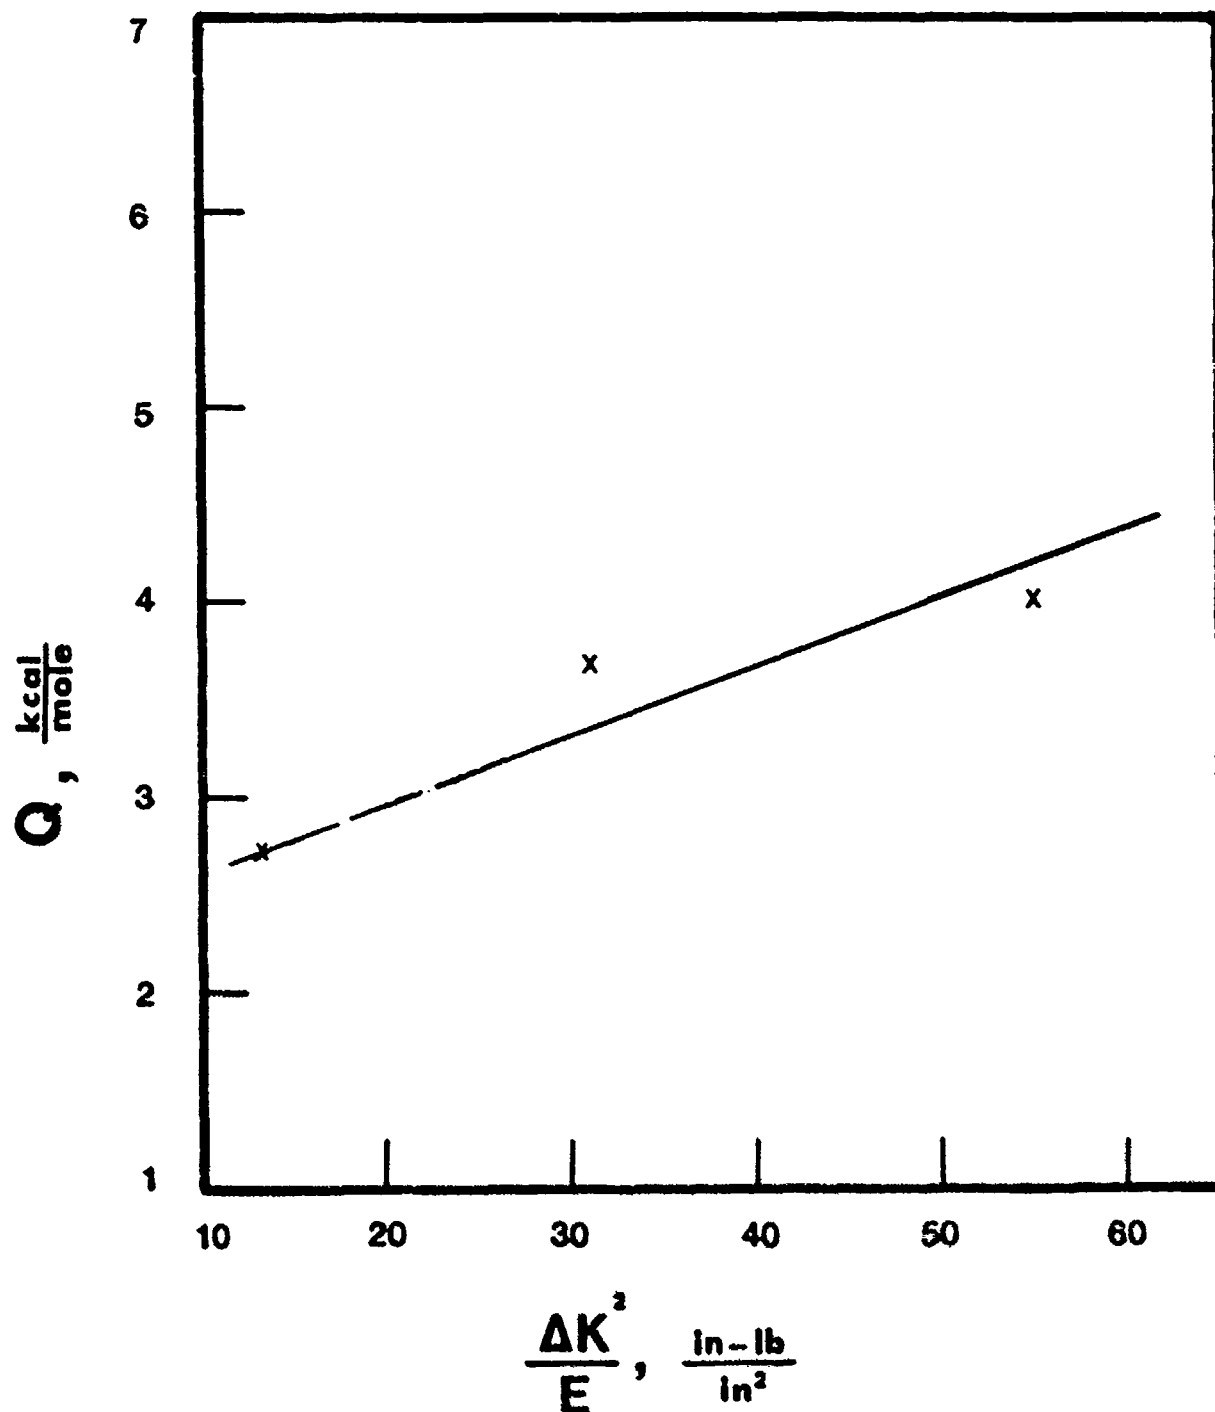
Fig. 53. Plot of Q versus $\frac{\Delta K^2}{E}$ to obtain the characteristic activation energy. ($E=29 \times 10^3$ ksi)
